Qualifying and **I**mplementing a user-centric designed and **E**fficient **T** electric vehicle

Project Acronym: **QUIET**

Deliverable No.	QUIET D4.2	
Deliverable Title	Assessment report for enhanced energy efficiency and comfort	
Scheduled Deliverable Date	2019-09	
Actual (granted) Deliverable Date	2020-02 (for preliminary version) For final version: when complete (agreed with the Project Officer)	
Deliverable Type	Report	
Dissemination level	Public	
Written by	Harald Grantner (AVL) Götz Lindenberg / Esther Kieseritzky (RUB) Daniel Habenbacher (ATT) Daniele Basciotti / Hansjörg Kapeller (AIT) Philipp Stegmüller (OBR) Christoph Pucher / Daniel Biernatzki (VEN)	2020-06-19 2020-02-21 2020-02-25 2020-04-17 2020-05-20 2020-05-20
Checked by	Jürgen Roither (AIT) Leo Götz (STS)	2020-06-25 2020-06-25
Approved by	WP Leader (AVL) Coordinator (AIT) Quality Coordinator (HRE-G)	2020-06-02 2020-06-25 2020-07-10
Status	Final version	2020-07-21

D4.2: ASSESSMENT REPORT FOR ENHANCED ENERGY EFFICIENCY AND COMFORT (PU)

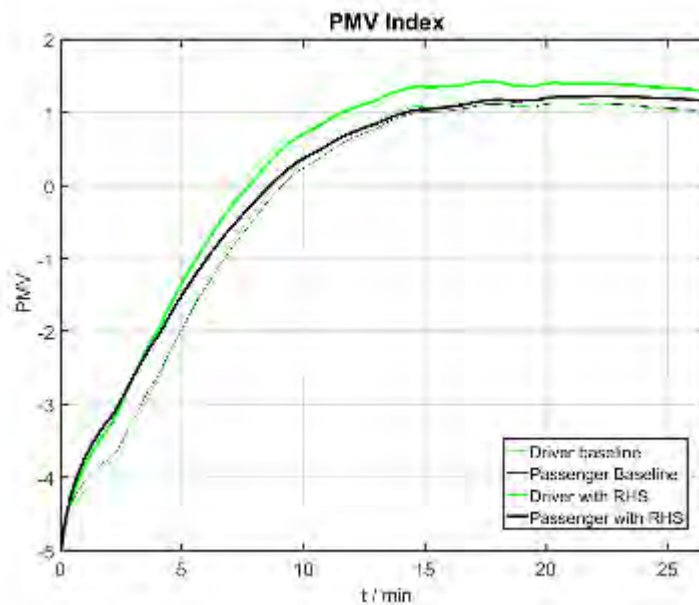
Figure 1: PMV Index for driver and passenger with and without heating elements

A simulation on passenger comfort and energy efficiency for the radiation heating elements was already presented in the previous deliverable D4.1. A short repetition of the results is given in Figure 1 to Figure 5. For detailed information on used boundary conditions, model settings, analysis approaches and further results please refer to deliverable D4.1.

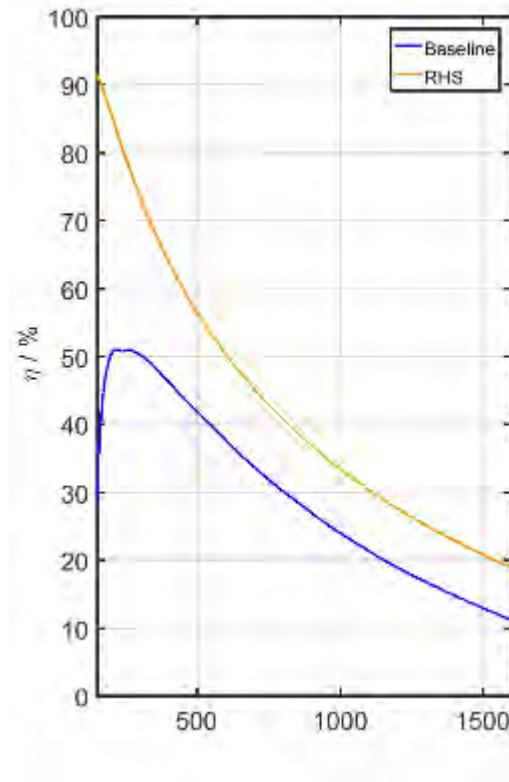
Figure 5: Efficiency over time

$$\eta = \frac{E_{IN} - E_{OUT}}{E_{IN}} \quad (2)$$

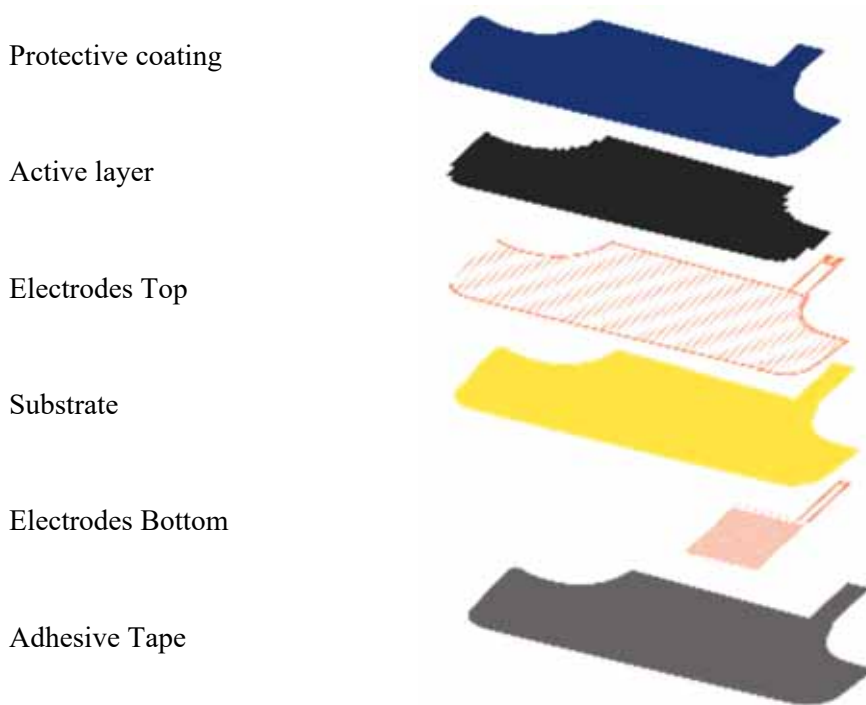
Figure 6: Layer structure of heating foil

the protection of the carbon ink on the top side, a thermal curing protective coating is also applied through a screen-printing process. With a special adhesive, the heating foils can be attached easily on the desired interior parts.

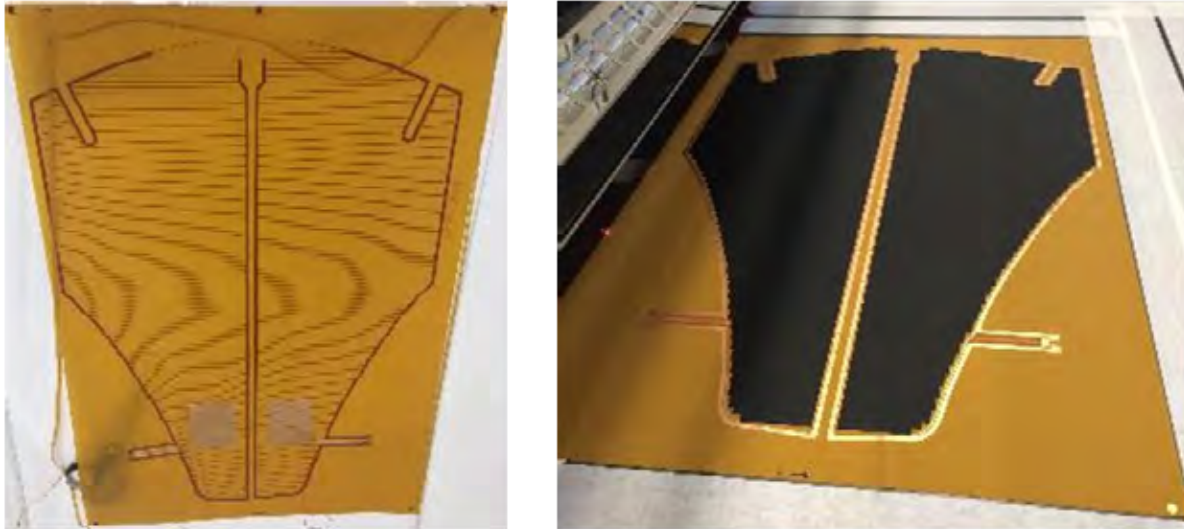
Figure 7: Substrate after etching- (left) and screen-printing process (right)

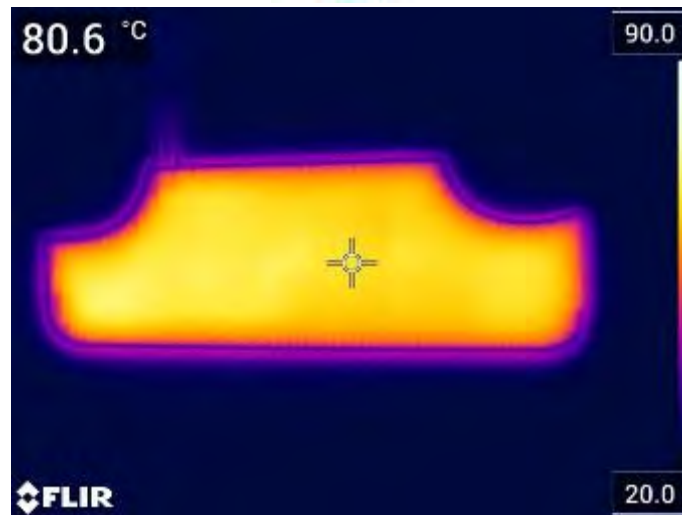
Since the sunvisor has the biggest distance between heating foil and user, the temperature of this heating foil will be higher than the others. Therefore, it was tested at higher temperatures. This is shown in Figure 8. It can be seen that the temperature distribution is homogeneous over the whole area.

Figure 8: Infrared picture of sunvisor at 80°C

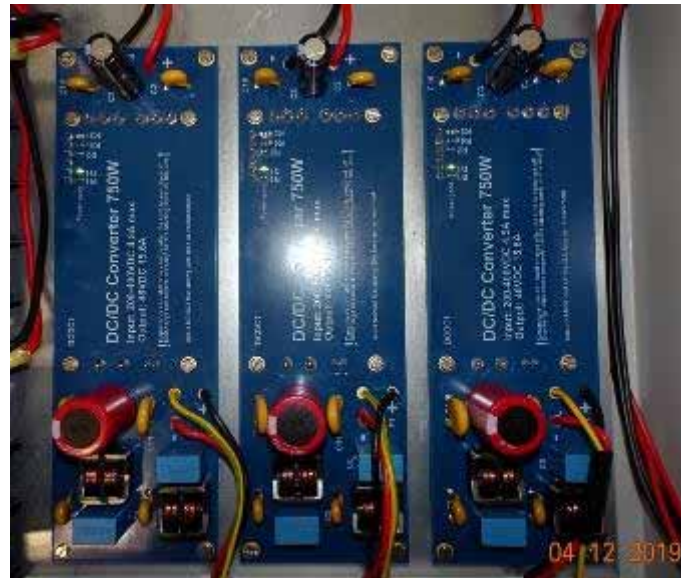
Each of the three DC/DC – converter modules, supplies up to three power modules. Each power module has two independent output channels. Therefore, each DC/DC converter is used to supply up to six heating foils.

Figure 9: three DC/DC converters

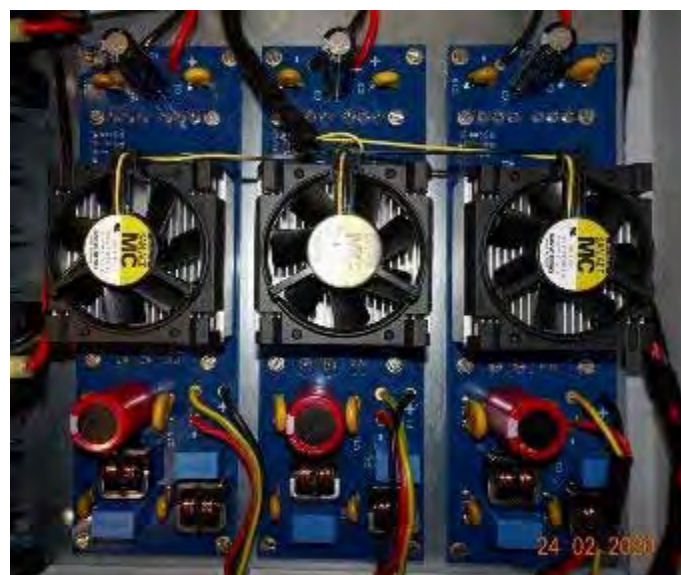
To dissipate the waste heat generated by the DC/DC converters, the modules themselves are mounted onto a 3 mm steel mounting plate of the used electrical cabinet. To increase thermal performance, a thermal conductive paste is used. In addition, a heatsink, including a cooling fan, is placed onto each power module to improve its thermal performance even more.

Figure 10: Heatsink with cooling fans

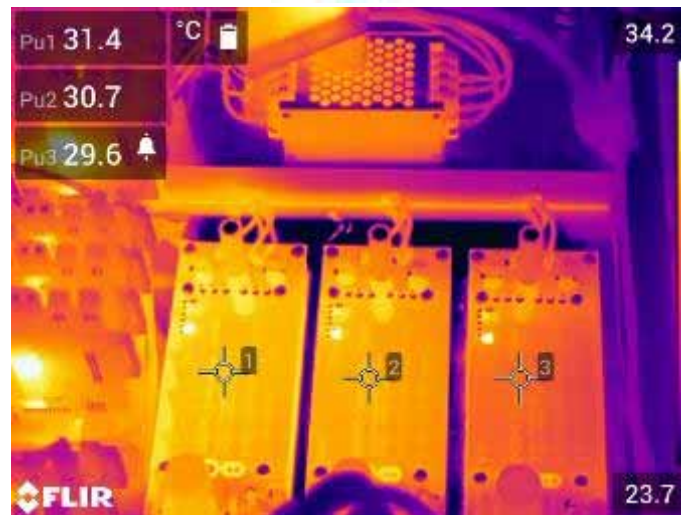
Figure 11: Infrared image of DC/DC converters in idle state

In the above thermal image, the heating of the DC/DC converter modules in idle state can be observed. This image is taken without the heatsinks and the cooling fan attached. An adequate test with maximum power output must be made.

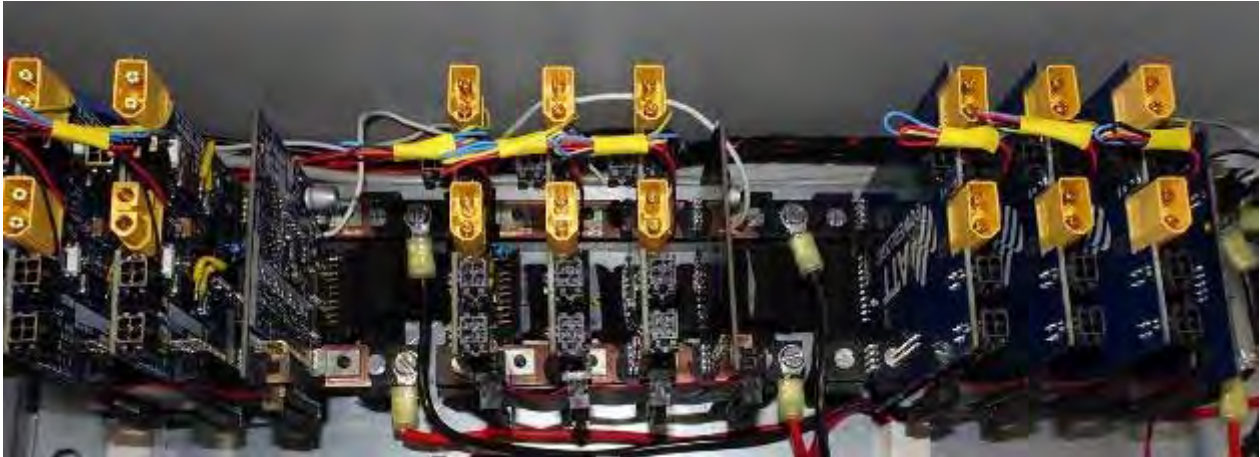
The arrangement of the control unit (CU) is shown in Figure 13. It can be seen that the CU is divided into three sections. Each section contains two or three power boards, which are those PCBs with the yellow connectors on top of them.

Figure 13: Arrangement of control unit

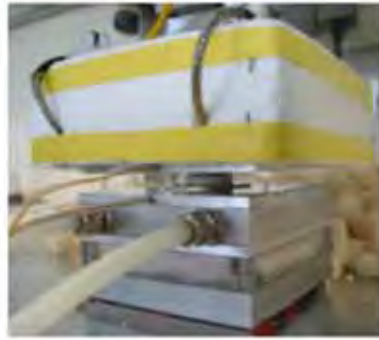
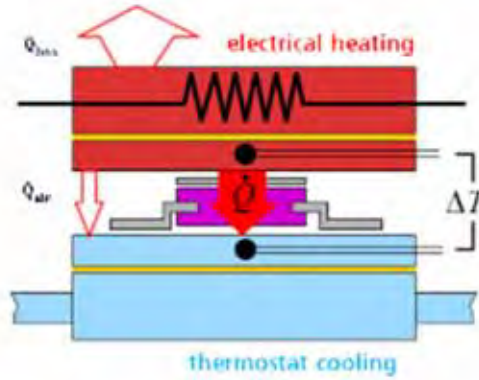
Figure 15: Apparatus for measurement of thermal conductivity

The Al foam were investigated in terms of thermal conductivity by IFAM. To be able to do so, samples of the Al foams were cut from a specimen, they were machined to obtain defined and parallel surfaces and the porosity was determined from sample weight and dimensions. A porosity value of 77.5% was found. The samples were measured three times, in between of the measurements they were completely removed, turned upside down and measured again. This was done to avoid problems with poor thermal contact. The used apparatus and the resulting thermal conductivity are shown in [Figure 15](#) and [Figure 16](#).

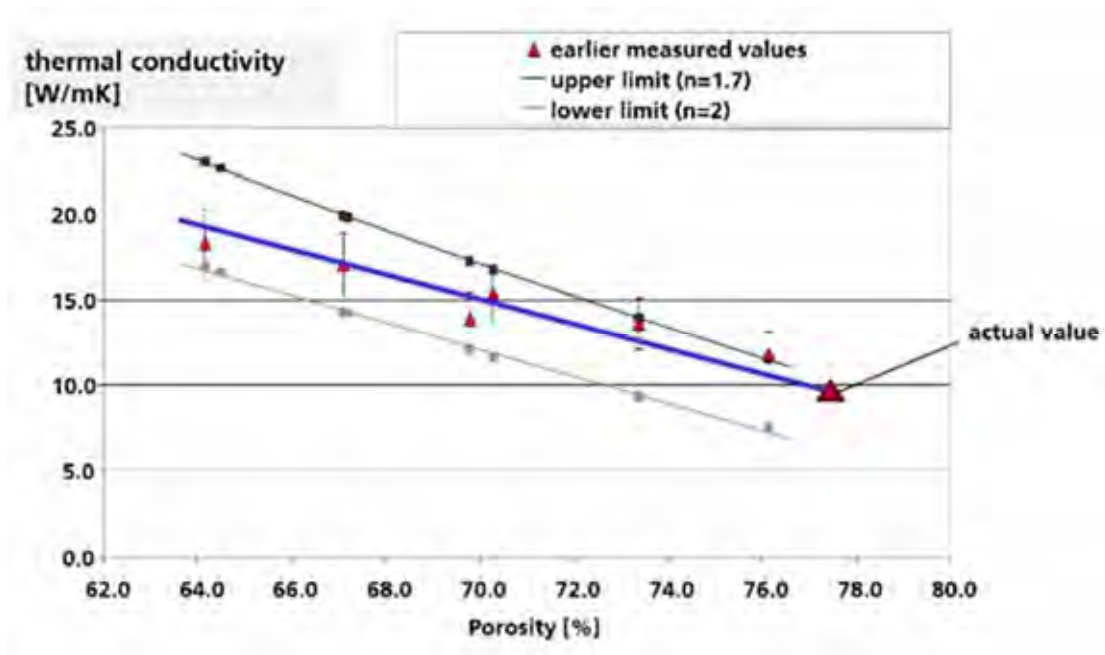
Figure 16: Thermal conductivity of the samples delivered to RUB

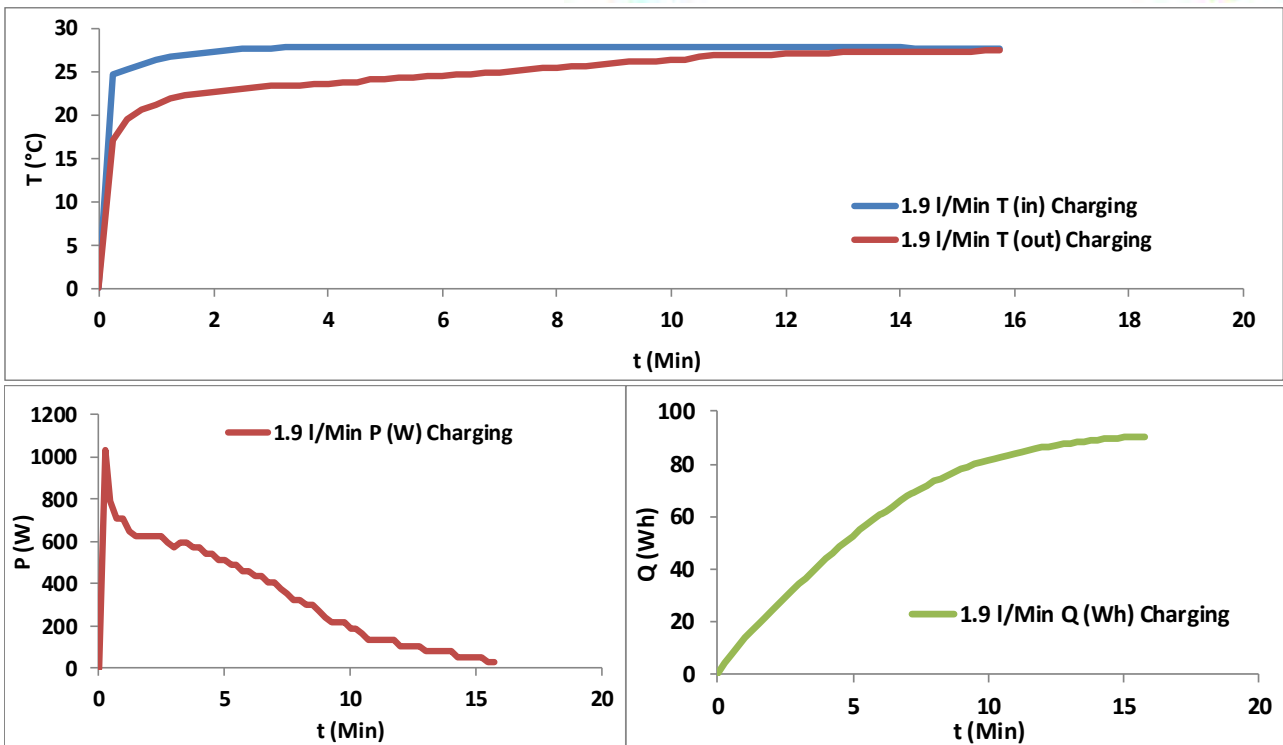
Figure 17: Measured data of thermal storage (Heat-up / Charging case @ \dot{v} coolant = 1.9 l/min)

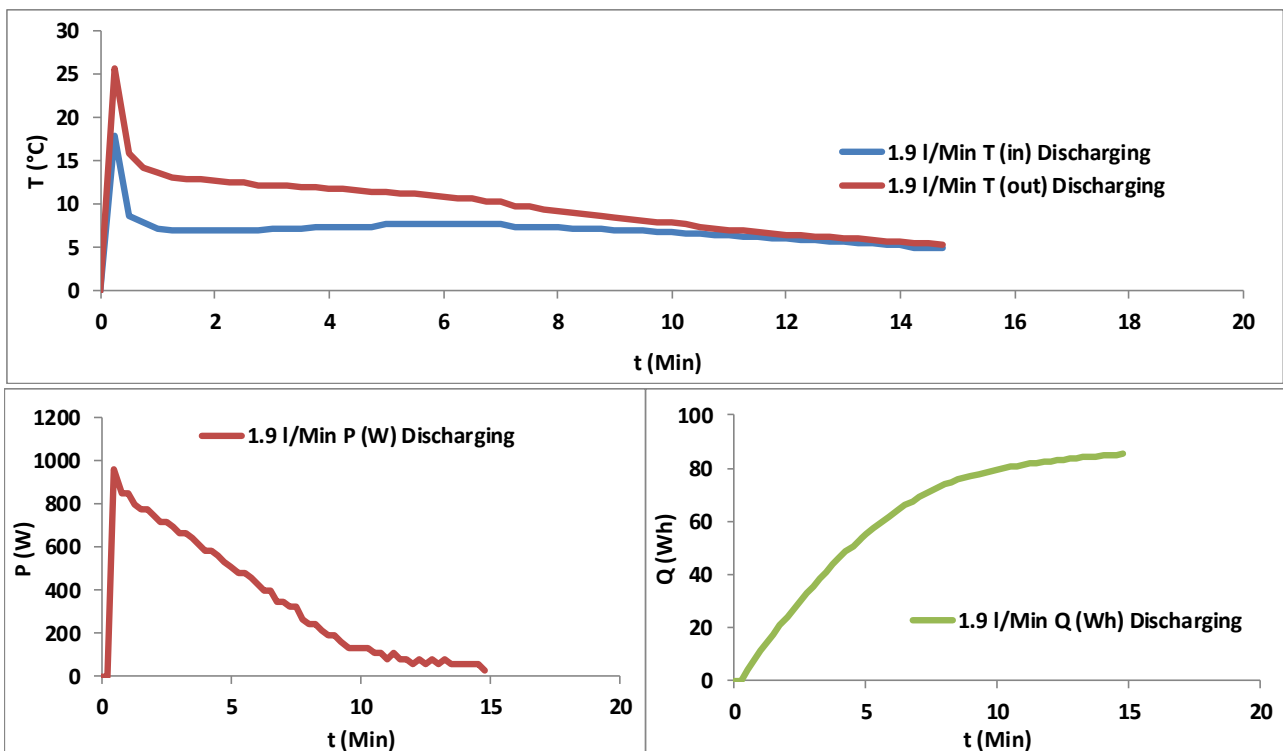
Figure 18: Measured data of thermal storage (Cool-down / Discharging case @ \dot{v} coolant = 1.9 l/min)

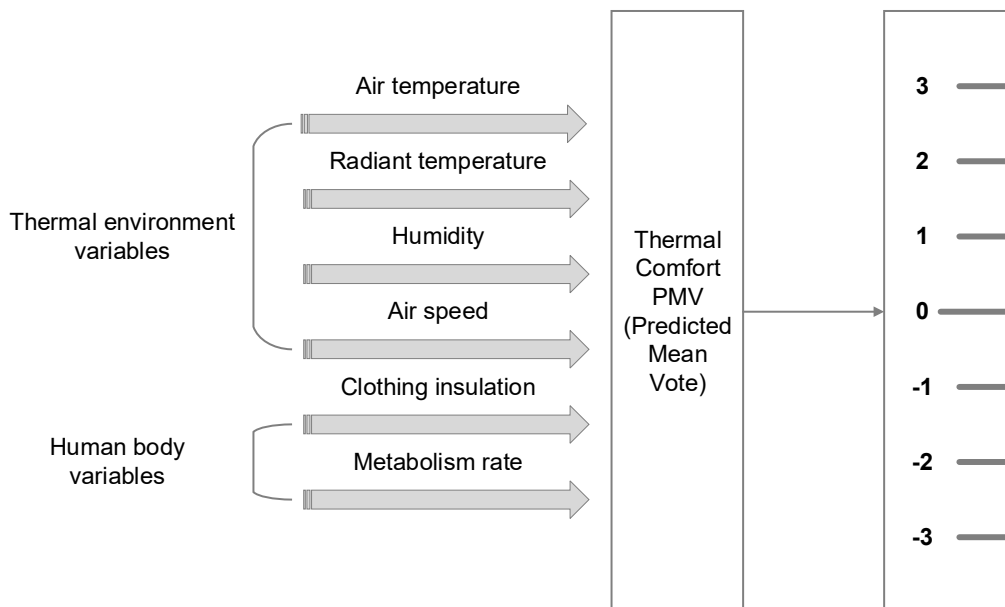
Figure 19: Thermal comfort model dependencies and scale

The index has been developed based on a large statistical research on a group of individuals, and it defines ranges that should result in thermal satisfaction for most of the occupants in a space. A PMV value of zero represents the ideal value considered as the thermal neutrality. However, values of the PMV Index in the range between -1.0 and +1.0 are considered acceptable and recommended (see Table 4).

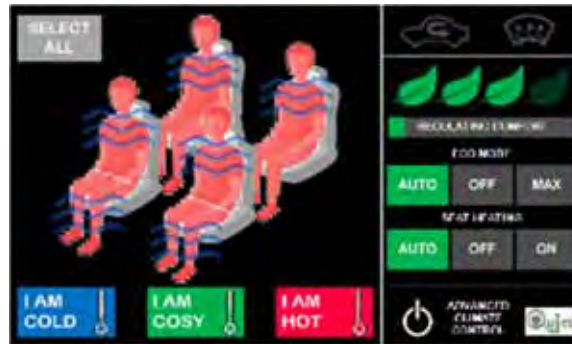
Figure 20: HMI settings for scenario 1

An overview of the settings for the HVAC system (mode, flaps and panels) and the HMI configuration (initial status of the cabin and selected actions from the user) is shown respectively in Table 6 and Figure 20. The Scenario 1 refers to the initial cabin thermal condition for which all passengers feel hot (e.g. entering the car after park conditions in summer). The HVAC system is set to cool down everybody in the cabin and the flaps are selected in position “HEAT-DEF”. Heating panels are turned off.

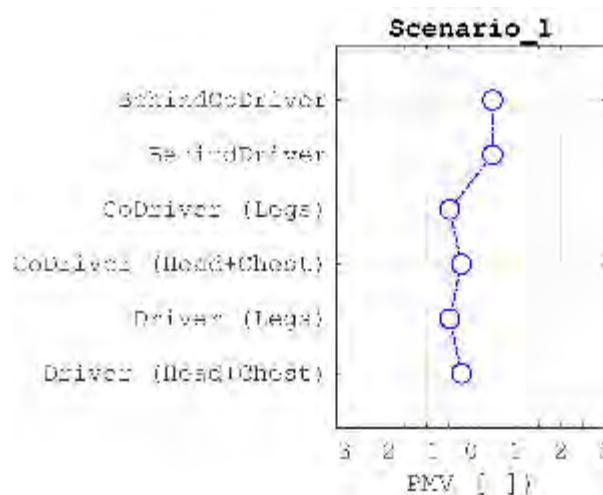
The evaluation of the results is presented in terms of PMV value in steady-state conditions (that is after 1h of cabin conditioning) and is shown in Figure 21. Six PMV values are presented and namely: one average PMV value for the passenger behind the driver and one for the codriver, and two separate PMV values both for the driver and the co-driver related to the legs area and the average value of heat and chest position.

Figure 21: PMV results for scenario 1

The results from the scenario 1 show that in steady state conditions the HVAC system is able to give to the passengers a comfortable thermal state, with all position in a neutral driver and co-driver legs area slightly cold (PMV ~ -0.5) and passengers on the back side feeling slightly warmer (PMV ~ +0.5).

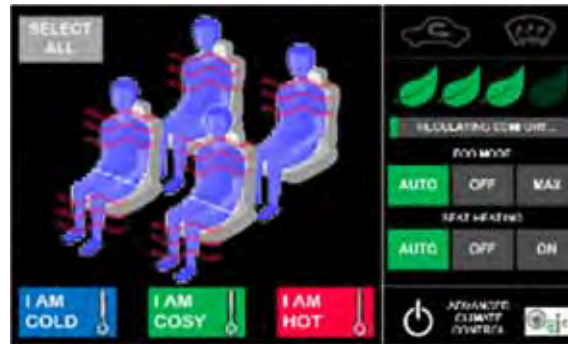
Figure 22: HMI settings for scenario 2

An overview of the settings for the HVAC system (mode, flaps and panels) and the HMI configuration (initial status of the cabin and selected actions from the user) is shown respectively in Table 7 and Figure 22. The Scenario 2 refers to the initial cabin thermal condition for which all passengers feel cold (e.g. entering the car after park conditions in winter). The HVAC system is set to heat up everybody in the cabin and the flaps are selected in position “BI-LEV”. Heating panels are turned on to ensure a faster thermal comfort response.

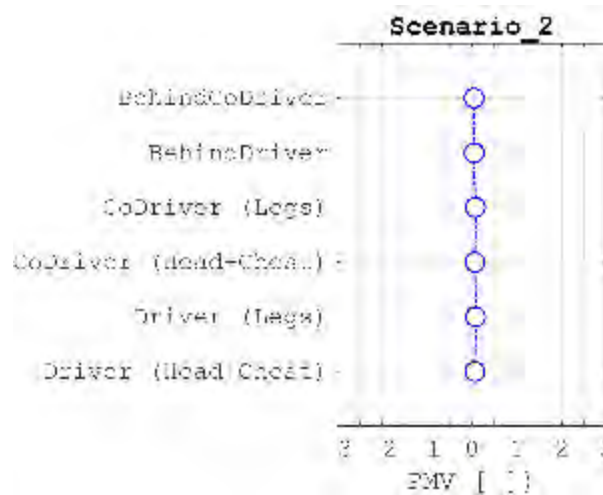
The evaluation of the results is presented in terms of PMV value in steady-state conditions (that is after 1h of cabin conditioning) and is shown in Figure 23. Six PMV values are presented and namely: one average PMV value for the passenger behind the driver and one for the codriver, and two separate PMV values both for the driver and the co-driver related to the legs area and the average value of heat and chest position.

Figure 23: PMV results for scenario 2

The results from the scenario 2 show that in steady state conditions the HVAC system is able to give to the passengers a comfortable thermal state, with all position in a neutral thermal state (PMV ~ 0).

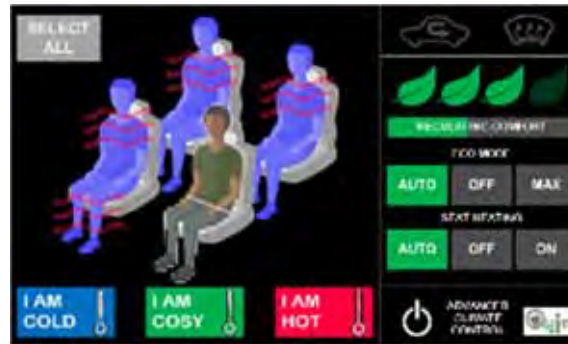
Figure 24: HMI settings for scenario 3

An overview of the settings for the HVAC system (mode, flaps and panels) and the HMI configuration (initial status of the cabin and selected actions from the user) is shown respectively in Table 8 and Figure 24. The Scenario 3 refers to the initial cabin thermal condition for which all passengers feel cold (e.g. entering the car after park conditions in winter). The HVAC system is set to heat up everybody in the cabin (except for the driver) and the flaps are selected in position “BI-LEV”. Heating panels are turned on except for the driver.

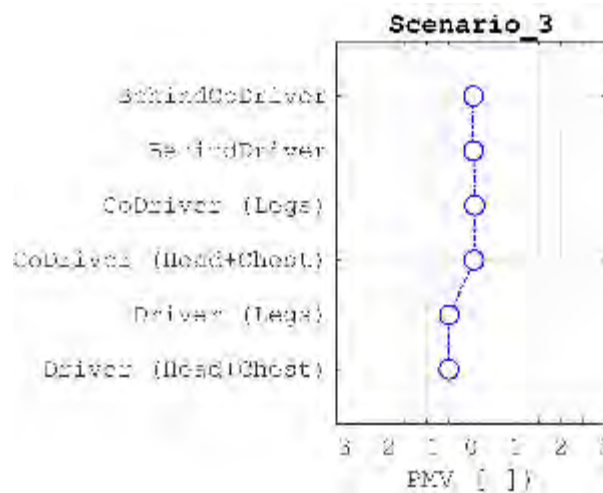
The evaluation of the results is presented in terms of PMV value in steady-state conditions (that is after 1h of cabin conditioning) and is shown in Figure 25. Six PMV values are presented and namely: one average PMV value for the passenger behind the driver and one for the codriver, and two separate PMV values both for the driver and the co-driver related to the legs area and the average value of heat and chest position.

Figure 25: PMV results for scenario 3

The results from the scenario 3 show that in steady state conditions the HVAC system is able to give to the passengers a comfortable thermal state, with driver feeling slightly cold (PMV ~ -0.5) and for the rest of the passengers a thermal neutral state (PMV ~ 0).

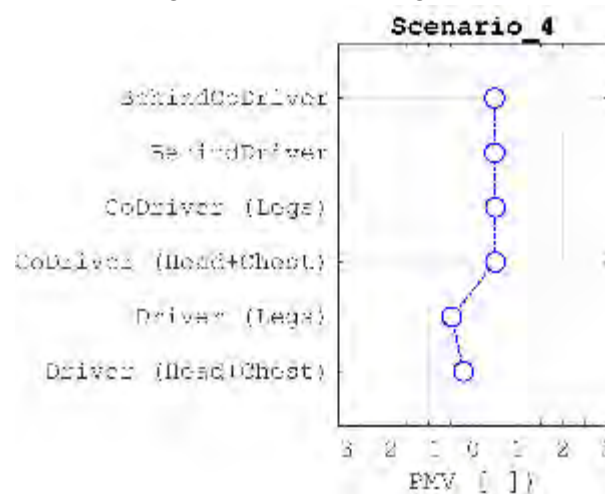
The evaluation of the results is presented in terms of PMV value in steady-state conditions (that is after 1h of cabin conditioning) and is shown in Figure 27. Six PMV values are presented and namely: one average PMV value for the passenger behind the driver and one for the codriver, and two separate PMV values both for the driver and the co-driver related to the legs area and the average value of heat and chest position.

Figure 27: PMV results for scenario 4

The results from the scenario 3 show that in steady state conditions the HVAC system is able to give to the passengers a comfortable thermal state, with driver legs position feeling slightly cold (PMV ~ -0.5) and for the rest of the body and rest of the passengers a thermal neutral state (PMV ~ 0).

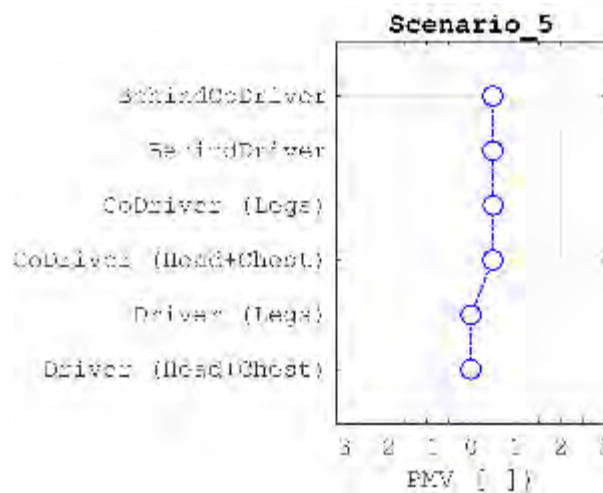
The evaluation of the results is presented in terms of PMV value in steady-state conditions (that is after 1h of cabin conditioning) and is shown in Figure 29. Six PMV values are presented and namely: one average PMV value for the passenger behind the driver and one for the codriver, and two separate PMV values both for the driver and the co-driver related to the legs area and the average value of heat and chest position.

Figure 29: PMV results for scenario 5

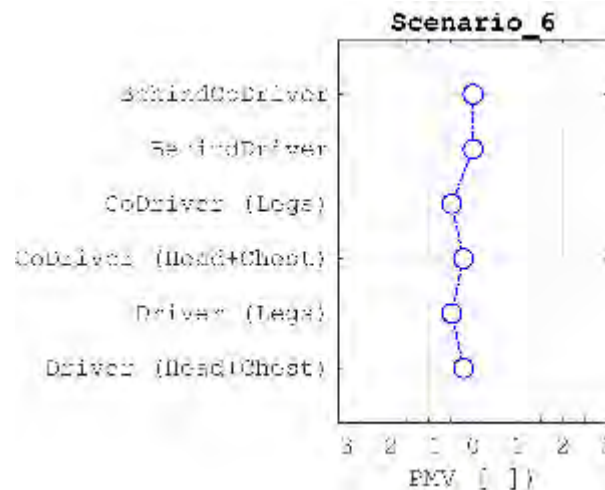
The evaluation of the results is presented in terms of PMV value in steady-state conditions (that is after 1h of cabin conditioning) and is shown in Figure 31. Six PMV values are presented and namely: one average PMV value for the passenger behind the driver and one for the codriver, and two separate PMV values both for the driver and the co-driver related to the legs area and the average value of heat and chest position.

Figure 31: PMV results for scenario 6

The results from the scenario 6 show that in steady state conditions the HVAC system is able to give to the passengers a comfortable thermal state, with values of PMV between -0.5 and 0.

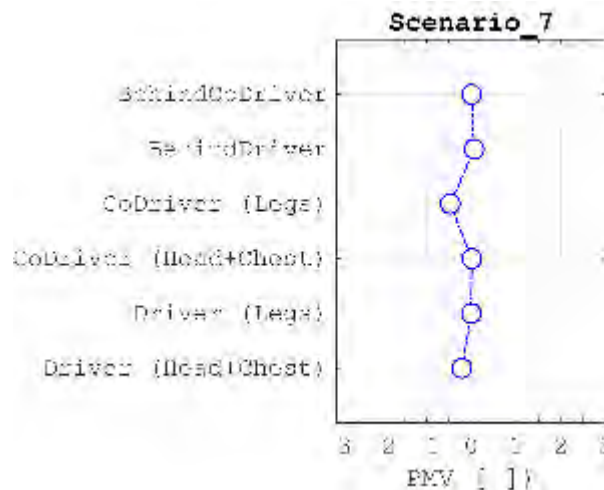
The evaluation of the results is presented in terms of PMV value in steady-state conditions (that is after 1h of cabin conditioning) and is shown in Figure 33. Six PMV values are presented and namely: one average PMV value for the passenger behind the driver and one for the codriver, and two separate PMV values both for the driver and the co-driver related to the legs area and the average value of heat and chest position.

Figure 33: PMV results for scenario 7

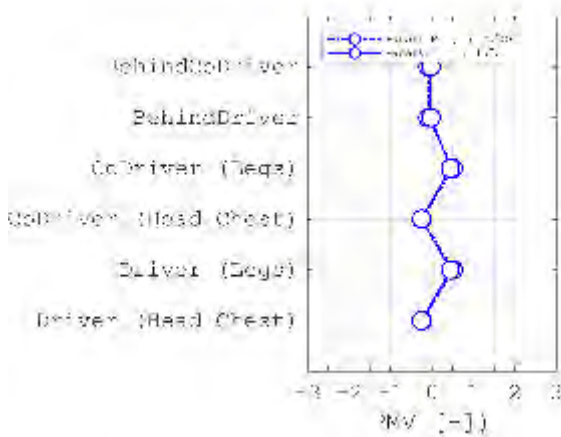
Figure 34: PMV results for the use case

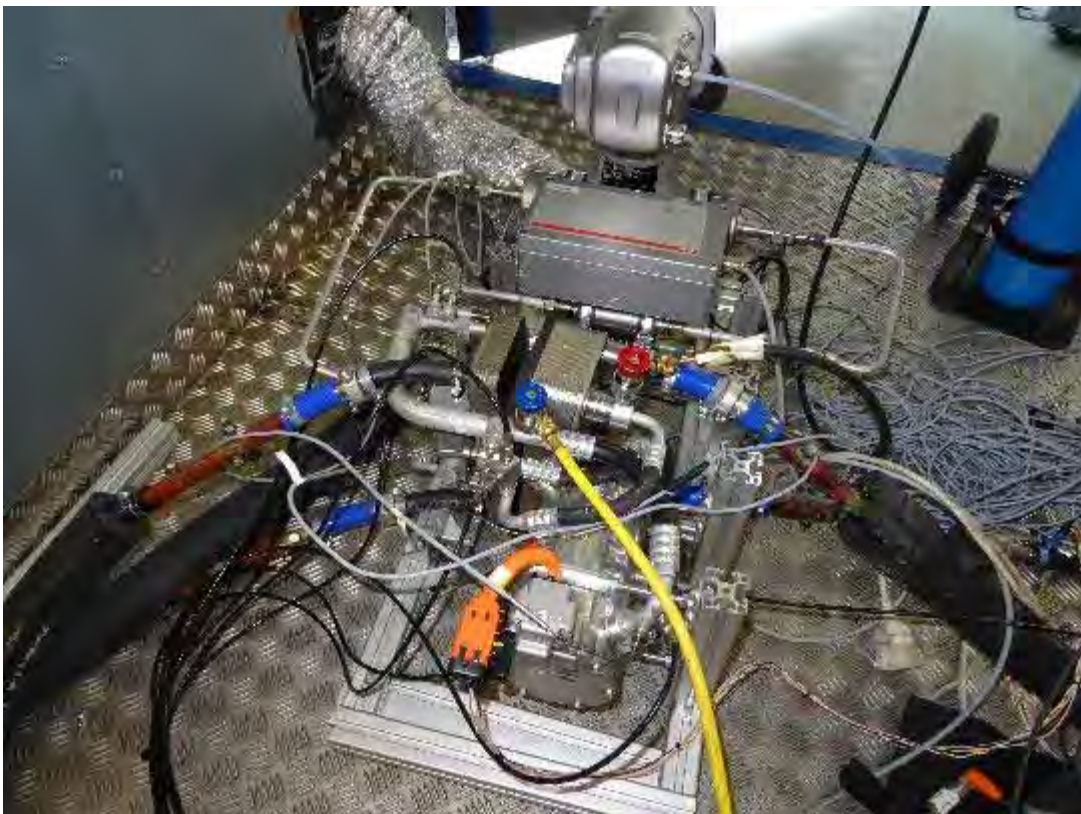
In step-1 the entire R290 refrigerant circuit was build up at the AC system testbed (see Figure 37), the two coolant circuits connected via refrigerant-coolant plate heat exchanger were represented by two separate conditioning units.

Figure 37: Build-up and instrumentation of Step-1 (R290 Micro-AC circuit) at AC system testbed

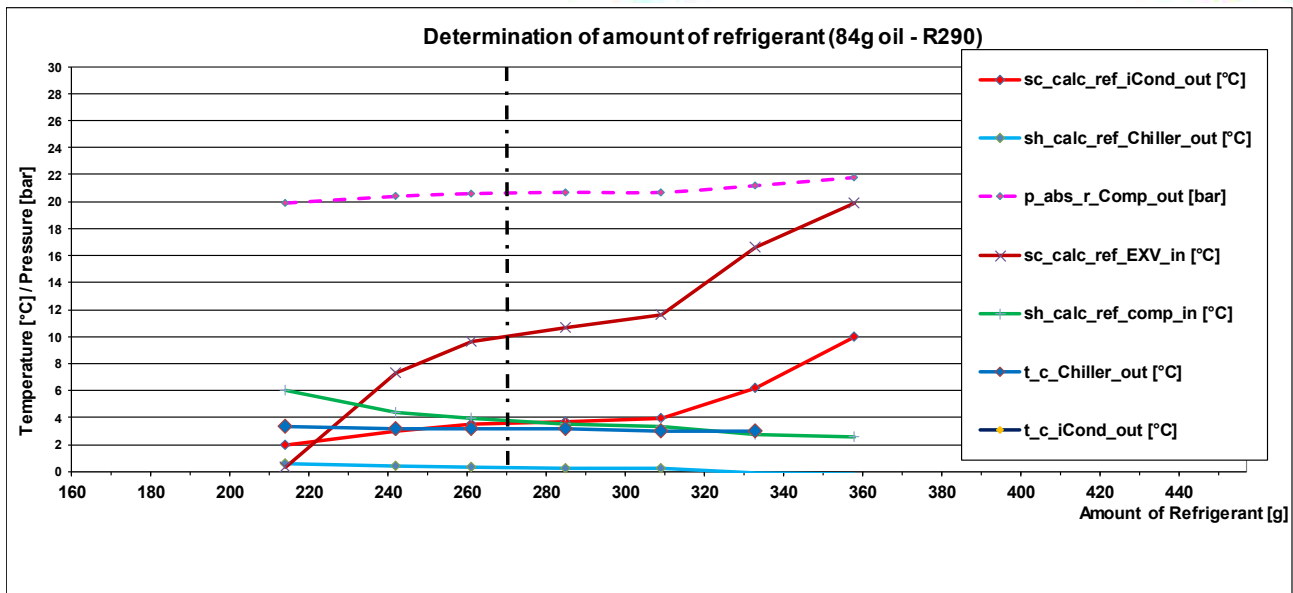
In Figure 40 the diagram depicting the correct amount of refrigerant is given.

Figure 40: Determination of necessary amount of refrigerant for the R290 Micro-AC circuit (incl. all measurement devices and additional piping included in testbed set-up)

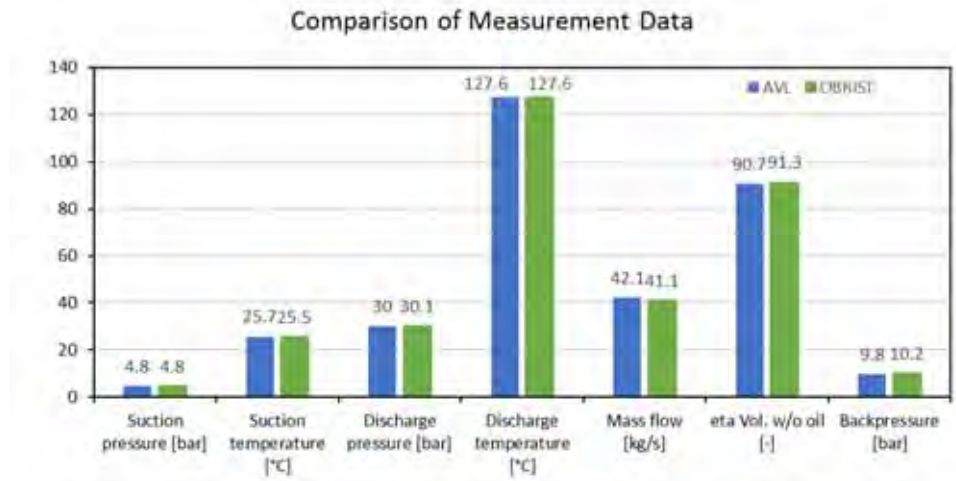
Figure 41: Reference point measurement data

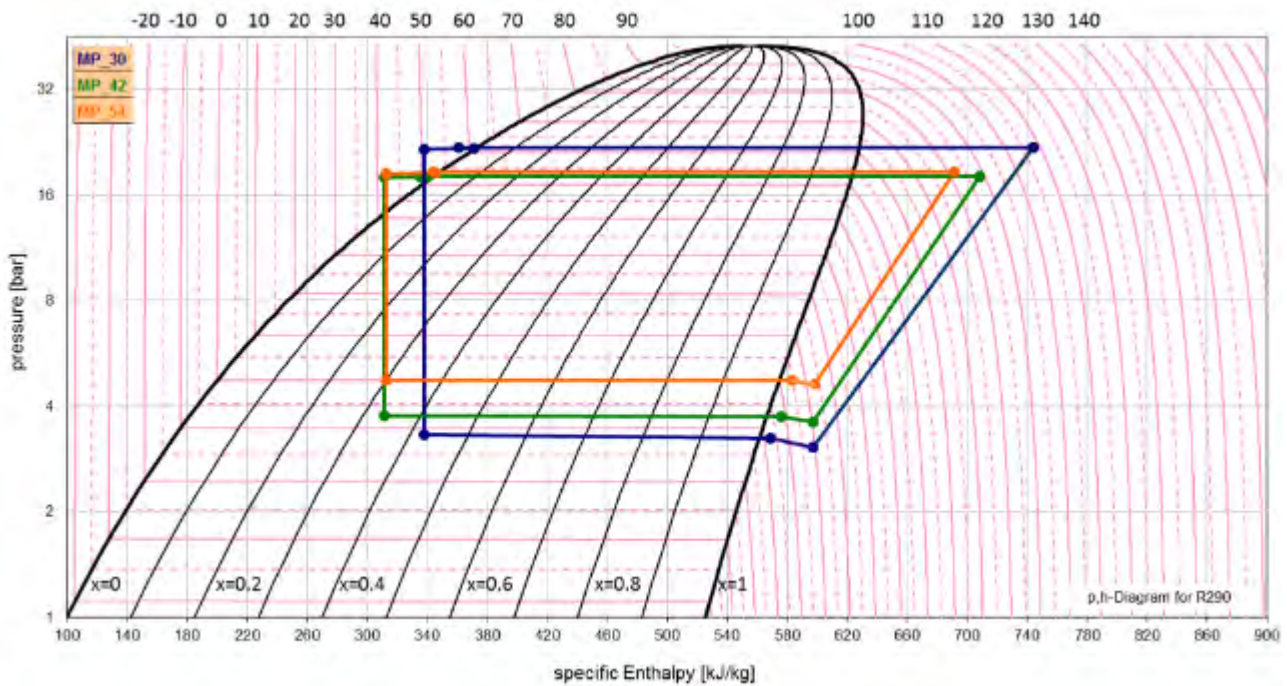
Figure 43: Measurement results of air conditioning modes for step 1

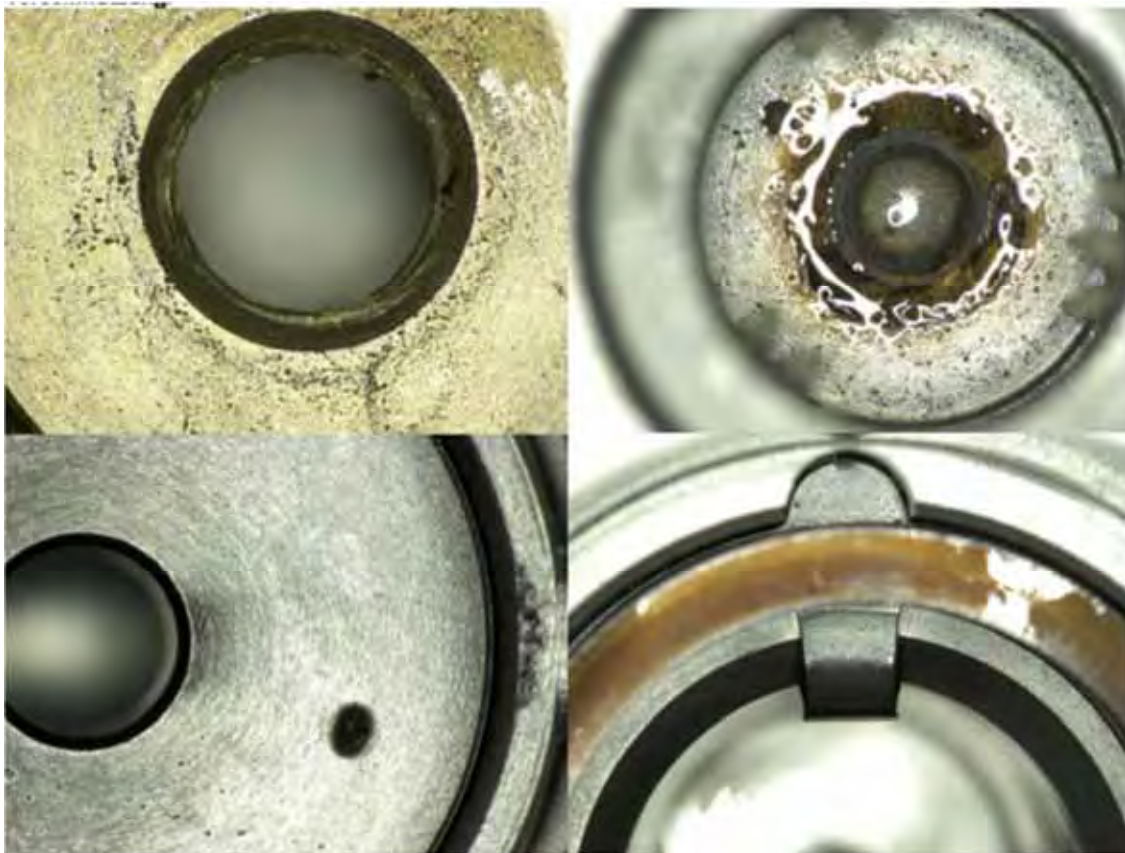
Figure 44: Contamination of EXV no. 2

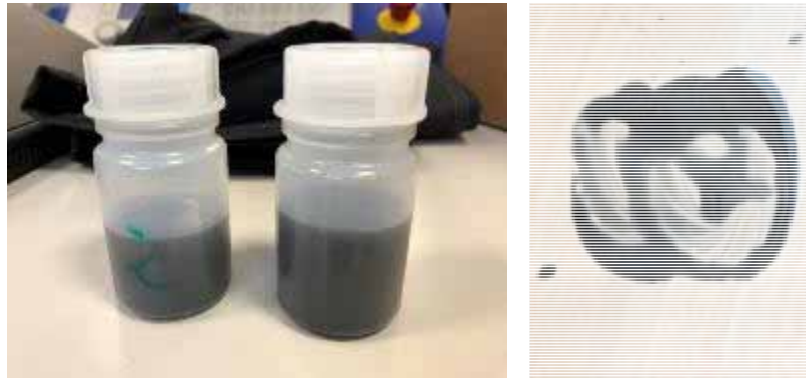
Figure 45: Oil drained from refrigerant circuit after failure of compressor no. 1

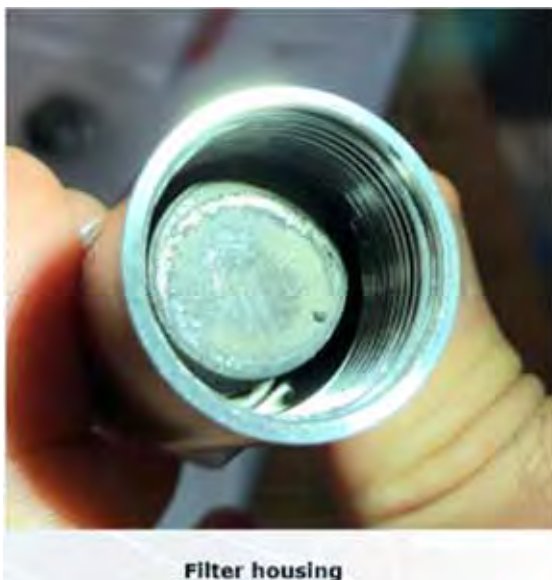
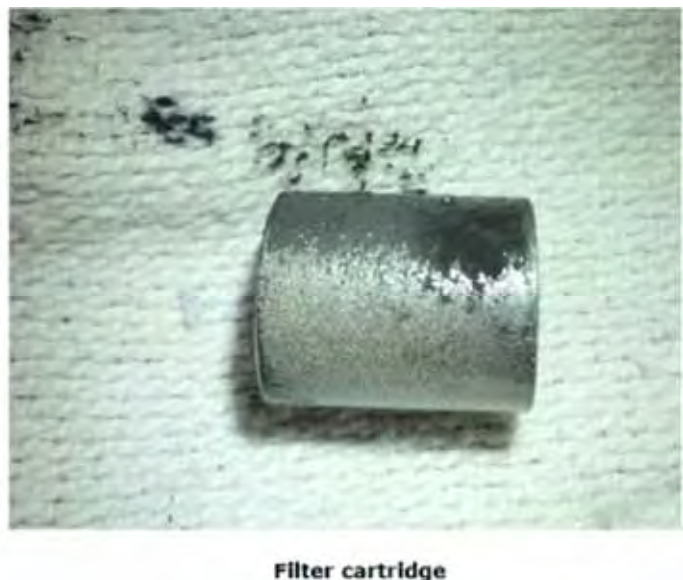
Figure 46: Contamination of the refrigerant filter after failure of compressor no. 1

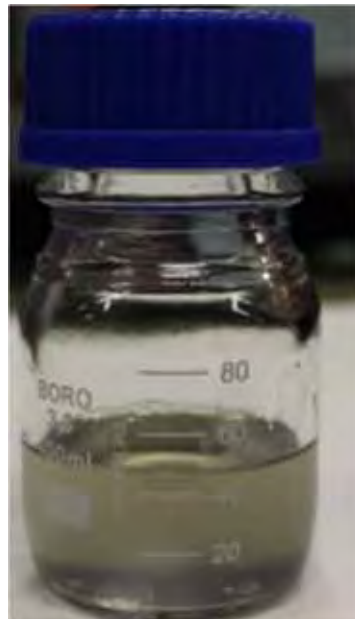
Figure 47: Oil drained from refrigerant circuit after 30 min of operation of compressor no. 2

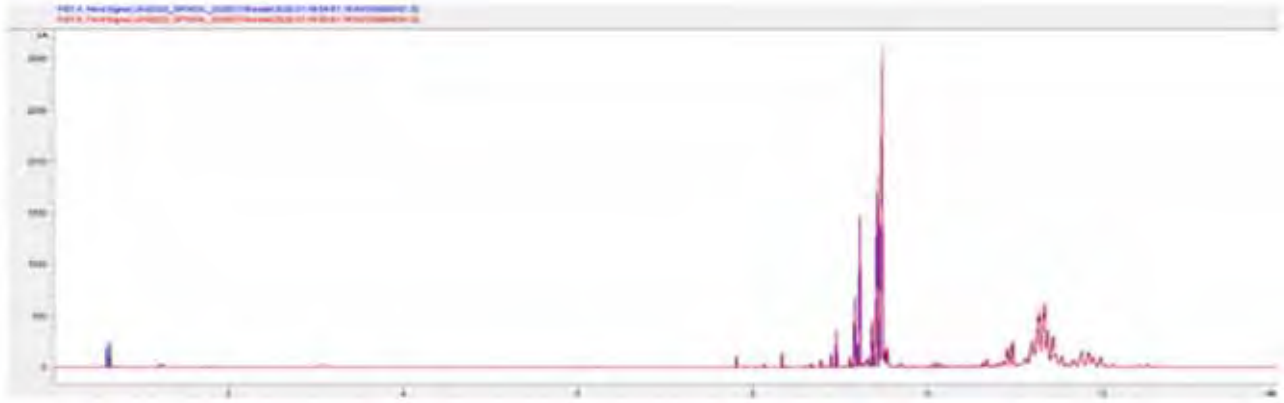
Figure 50: Results of gas-chromatography analysis of oil - excerpt

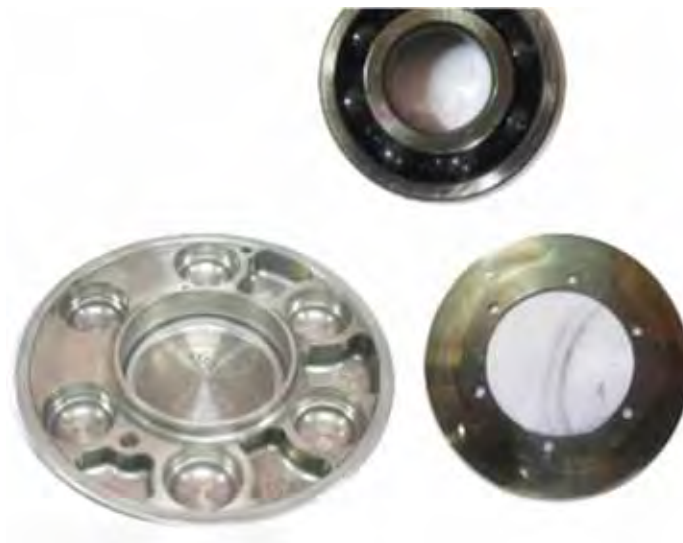
Figure 51: Compressor no. 1 - Bearings after failure

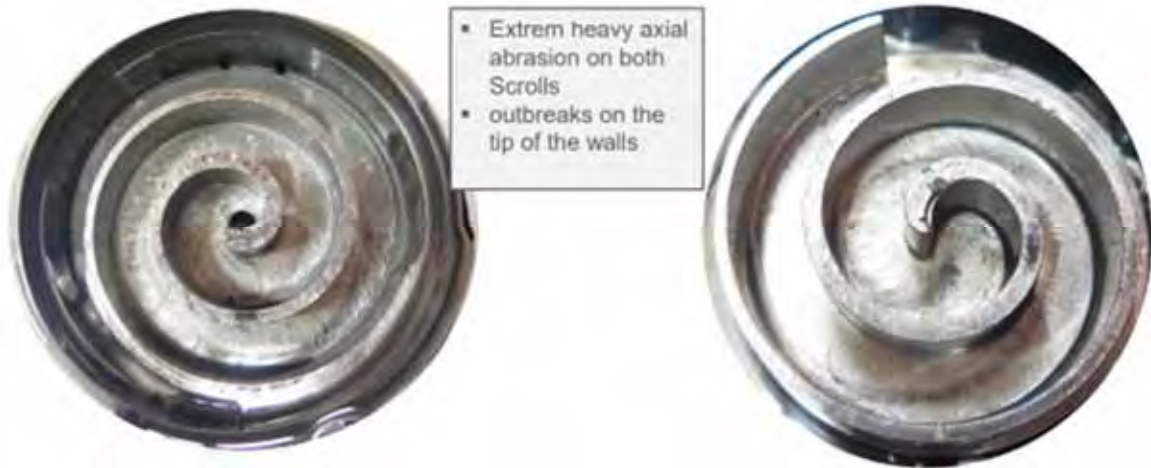
Figure 52: Compressor no. 1 - Scrolls after failure

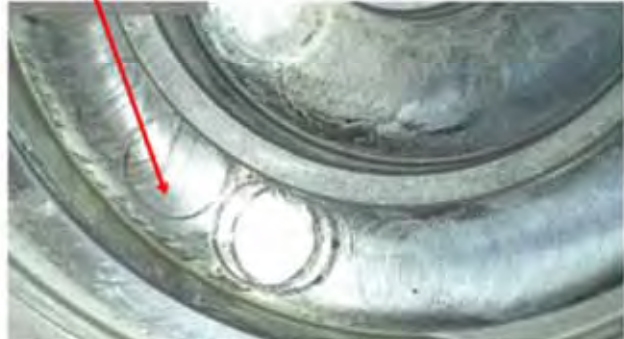
Figure 54: Compressor no. 2 – Wear marks at scroll after 30 min operation

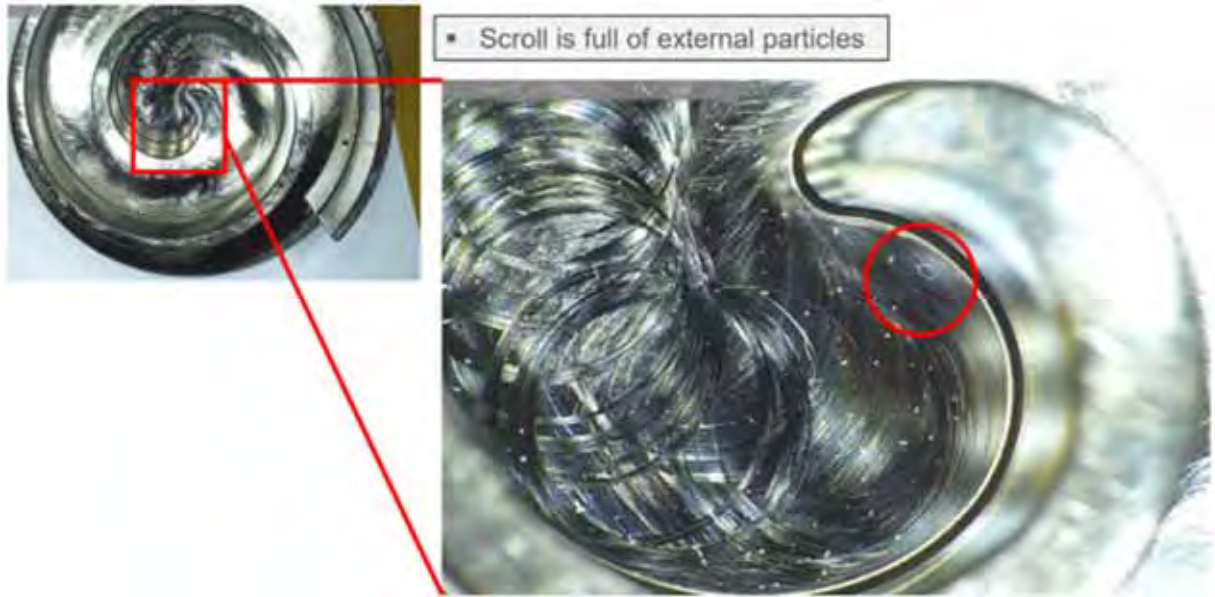
▪ Indication for external particles like polymer, resin or adhesive at Scroll Inlet

Figure 56: Compressor no. 2 –External particles at scroll inlet after 30 min of operation

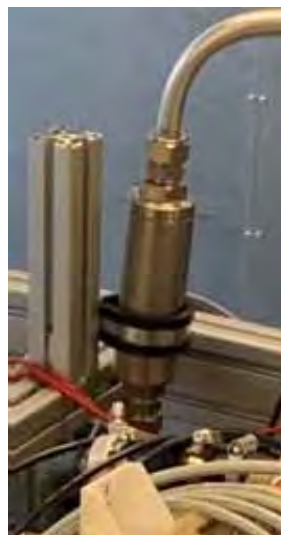
Figure 57: Refrigerant filter installed before the compressor on testbed

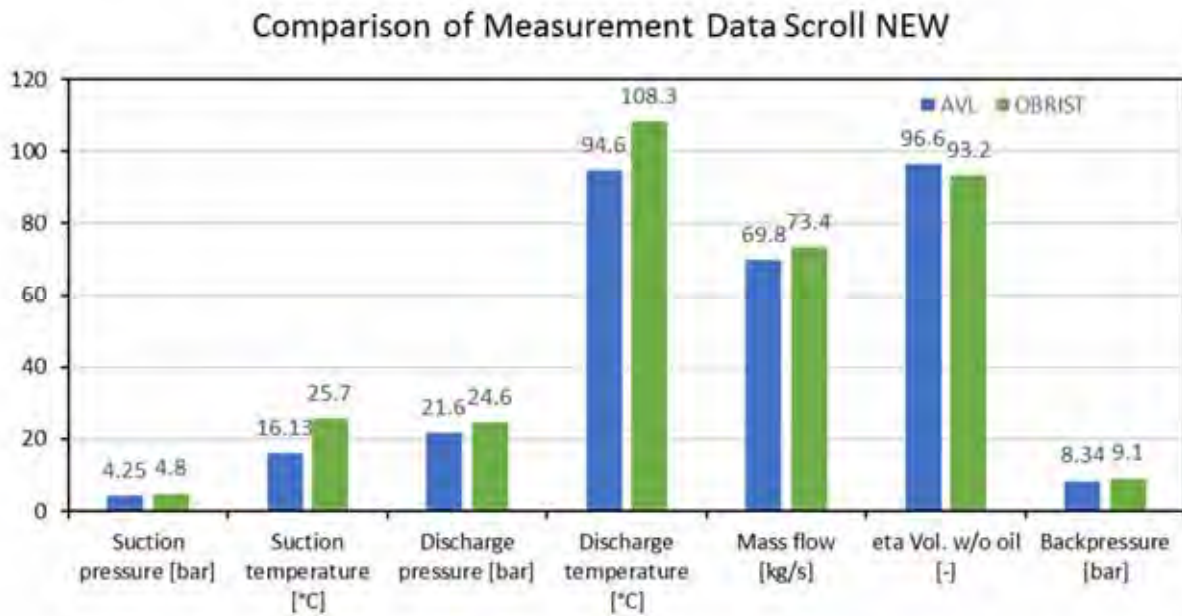
Figure 59: Reference measurement data for rebuilt compressor no. 2 (Step-1)
