Qualifying and **I**mplementing a user-centric designed and **E**fficient **T** electric vehicle

Project Acronym: **QUIET**

Deliverable No.	QUIET D4.2	
Deliverable Title	Assessment report for enhanced energy efficiency and comfort	
Scheduled Deliverable Date	2019-09	
Actual (granted) Deliverable Date	2020-02 (for preliminary version) For final version: when complete (agreed with the Project Officer)	
Deliverable Type	Report	
Dissemination level	Public	
Written by	Harald Grantner (AVL) Götz Lindenberg / Esther Kieseritzky (RUB) Daniel Habenbacher (ATT) Daniele Basciotti / Hansjörg Kapeller (AIT) Philipp Stegmüller (OBR) Christoph Pucher / Daniel Biernatzki (VEN)	2020-06-19 2020-02-21 2020-02-25 2020-04-17 2020-05-20 2020-05-20
Checked by	Jürgen Roither (AIT) Leo Götz (STS)	2020-06-25 2020-06-25
Approved by	WP Leader (AVL) Coordinator (AIT) Quality Coordinator (HRE-G)	2020-06-02 2020-06-25 2020-07-10
Status	Final version	2020-07-21

D4.2: ASSESSMENT REPORT FOR ENHANCED ENERGY EFFICIENCY AND COMFORT (PU)

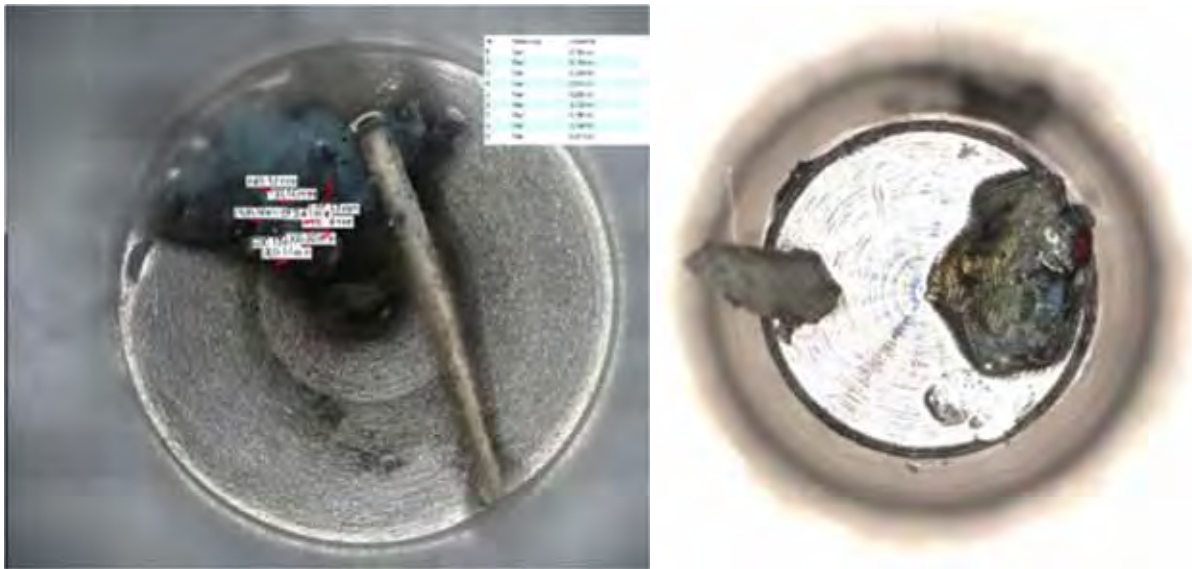
Figure 60: 2nd failure of EXV no. 2 – particles in EXV no. 2

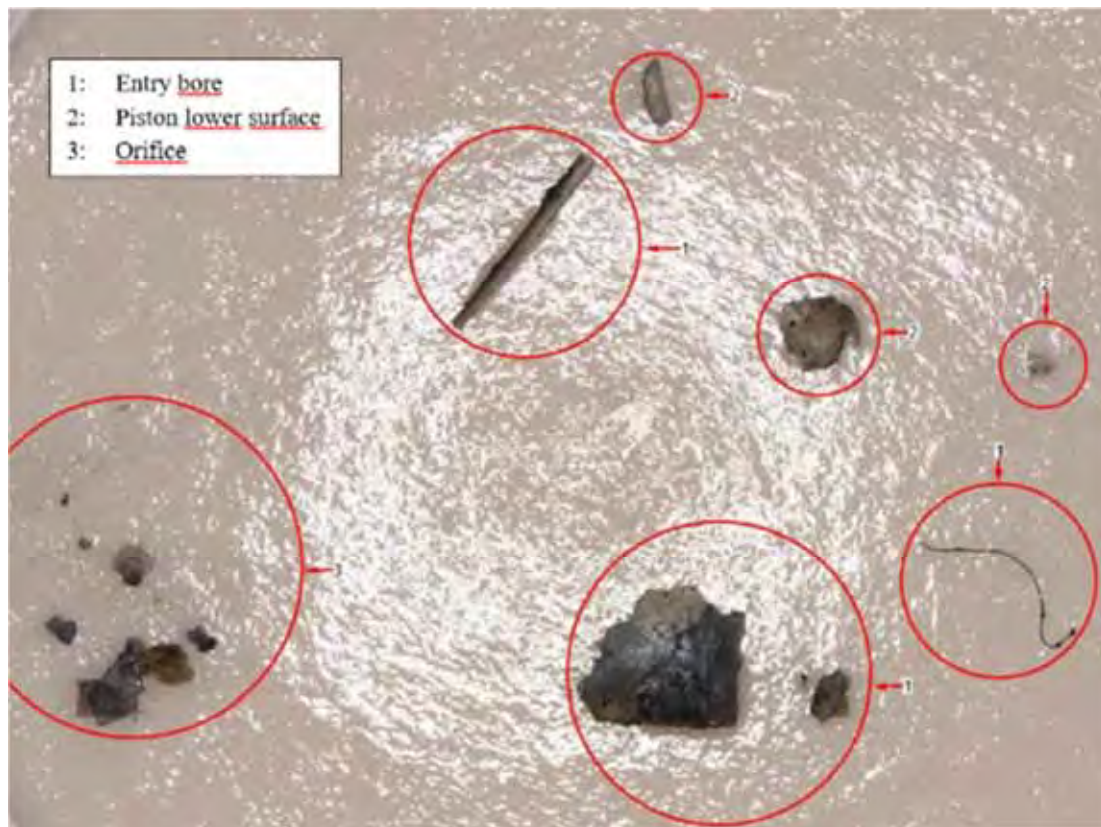
Figure 61: 2nd failure of EXV no. 2 – particles found

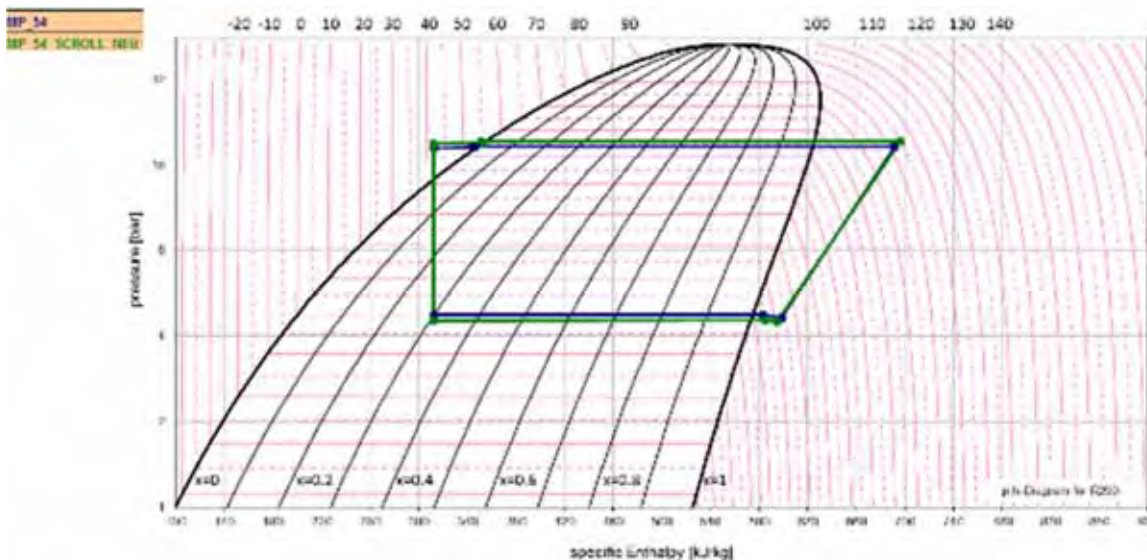
Figure 62: Comparison of AC measurement point before and after the failures

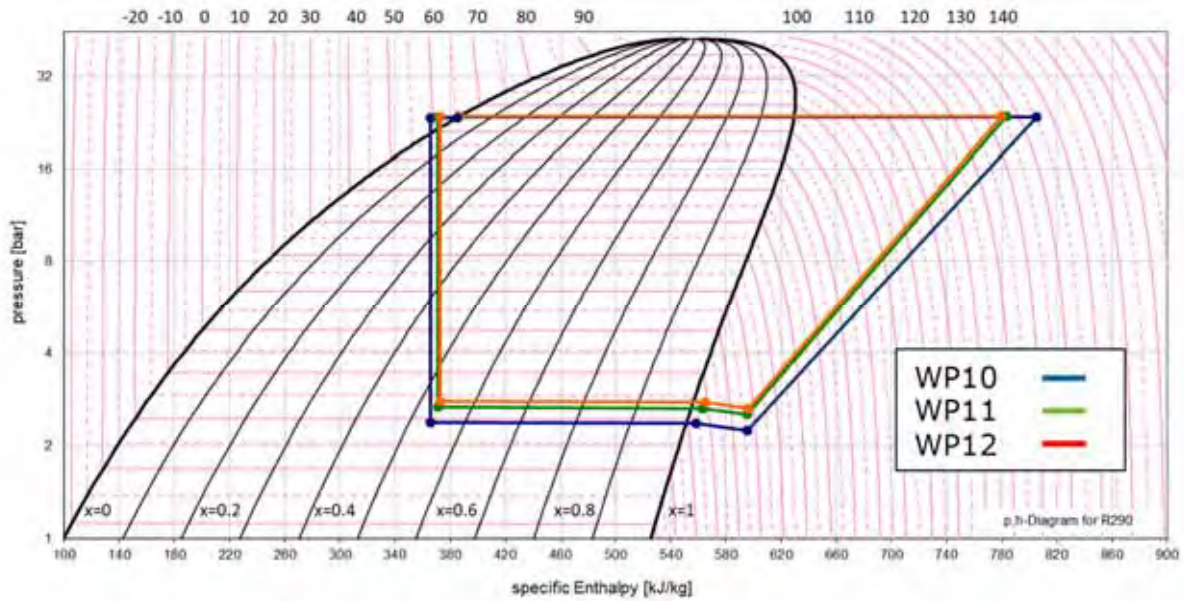
Figure 63: Result for different operational conditions in heat pump mode measurements

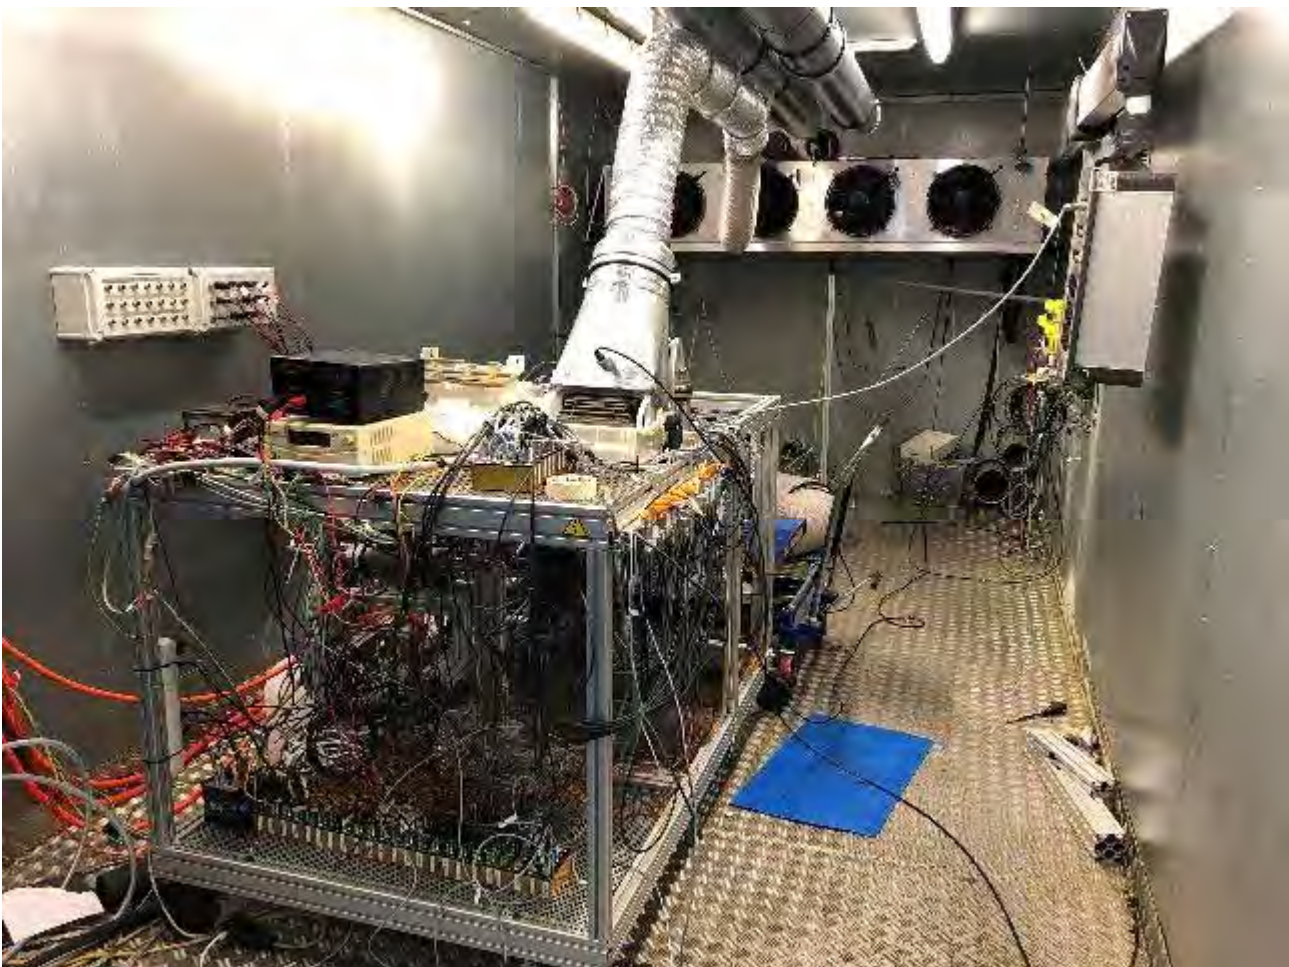
Figure 65: Build-up and instrumentation of Step-2 (entire VTMS) at AC system testbed

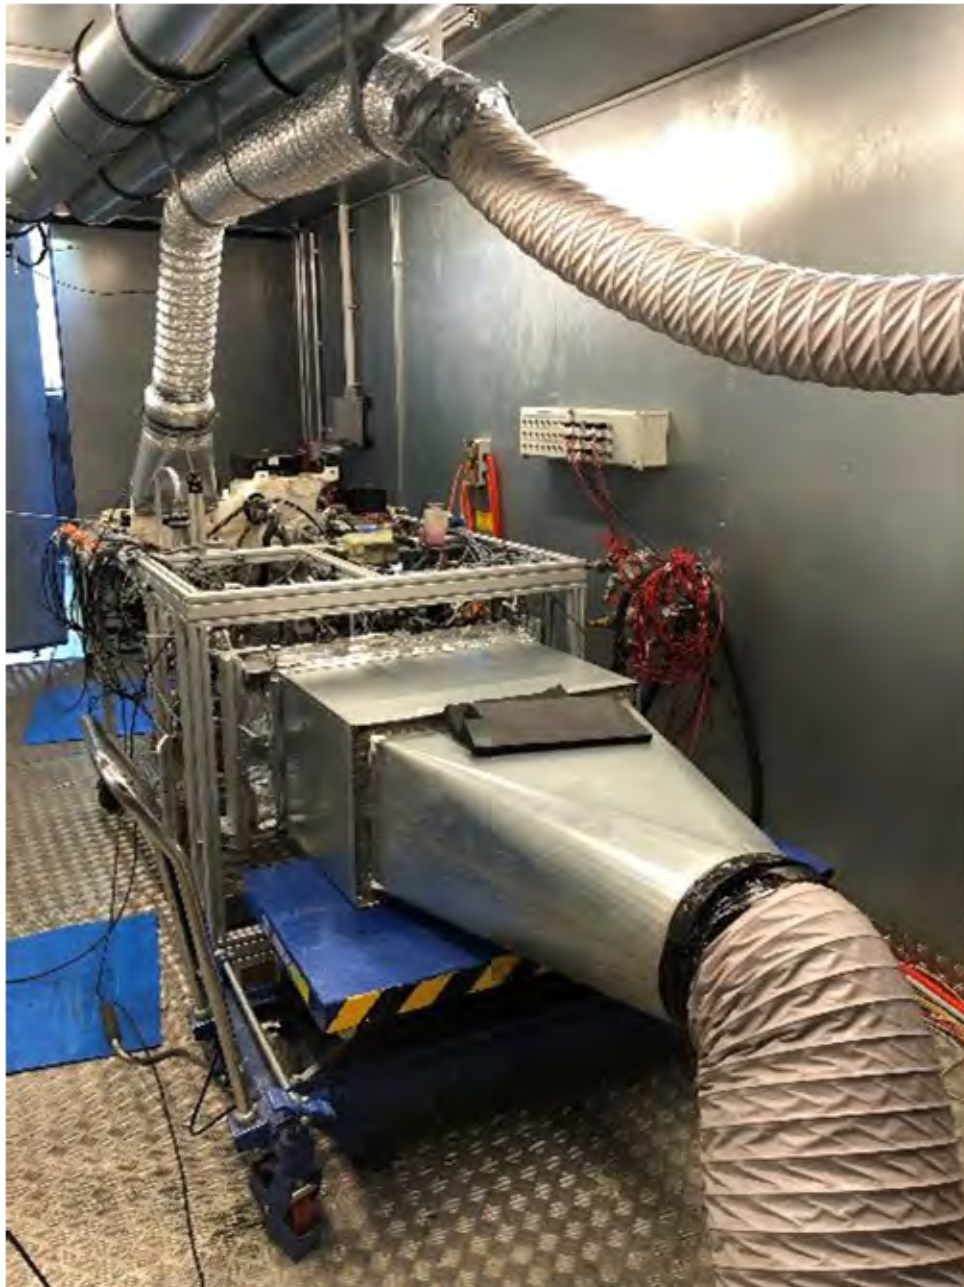
Figure 66: Build-up and instrumentation of Step-2 (entire VTMS) at AC system testbed

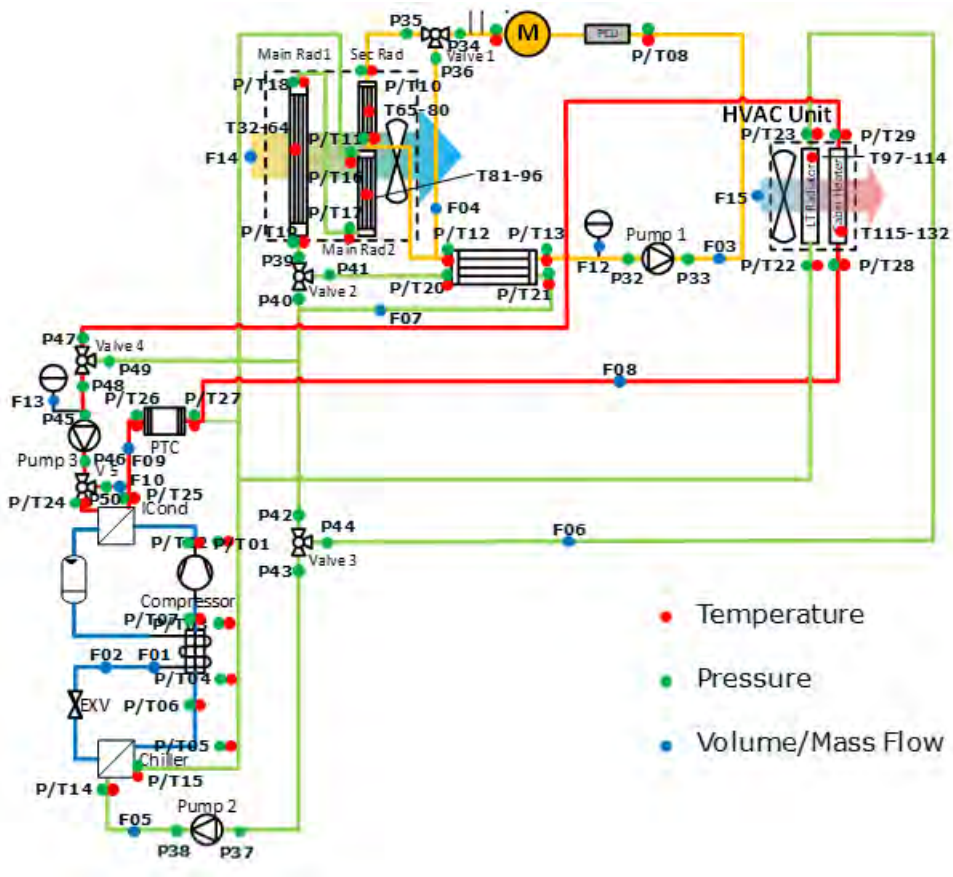
Figure 67: Instrumentation of testbed build-up for Step-2 (entire VTMS)

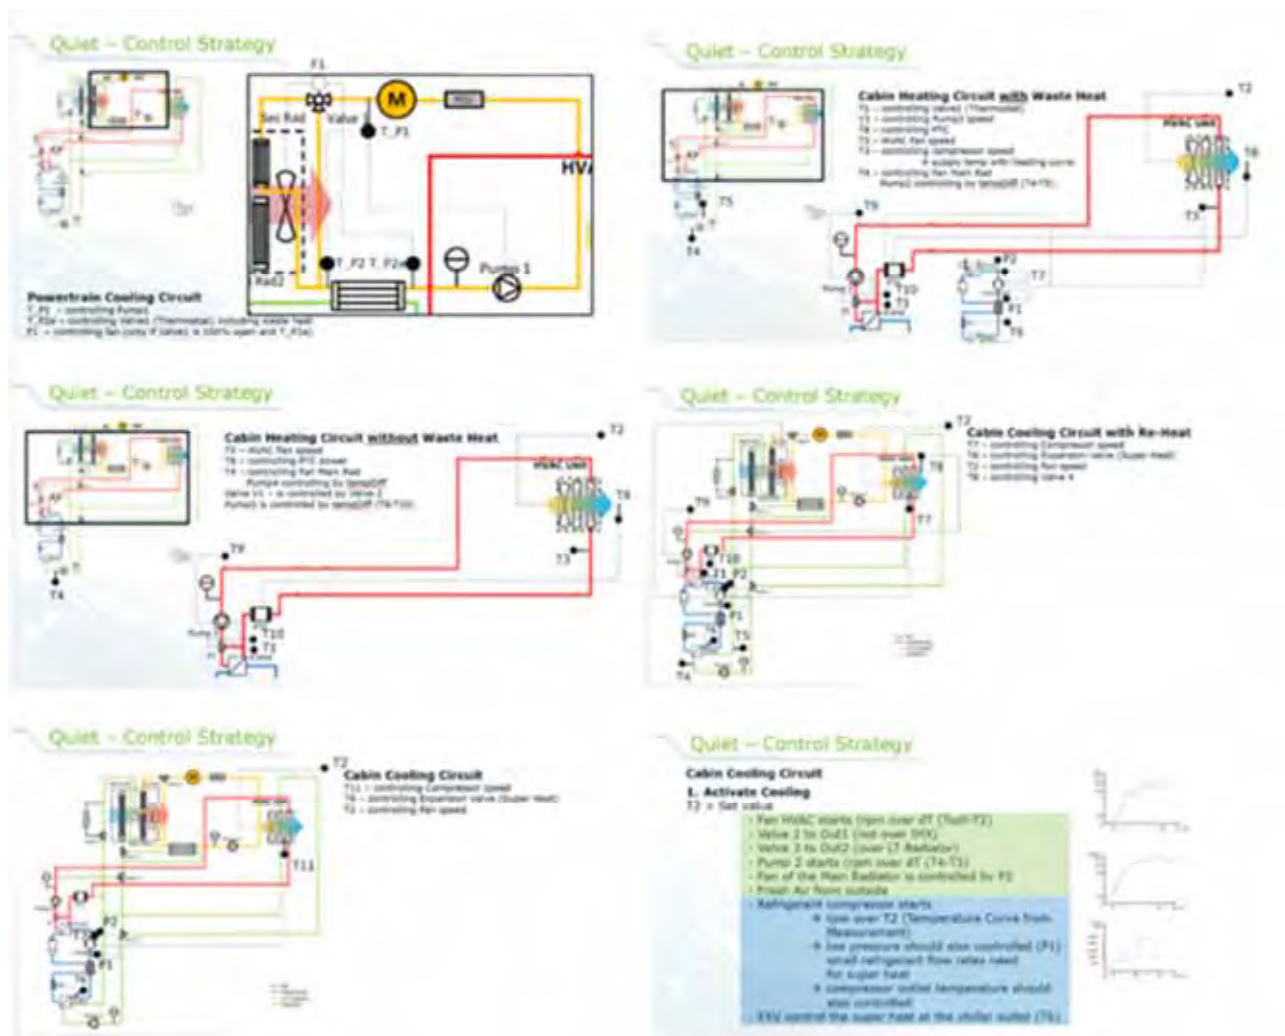
Figure 68: Control strategy for entire VTMS

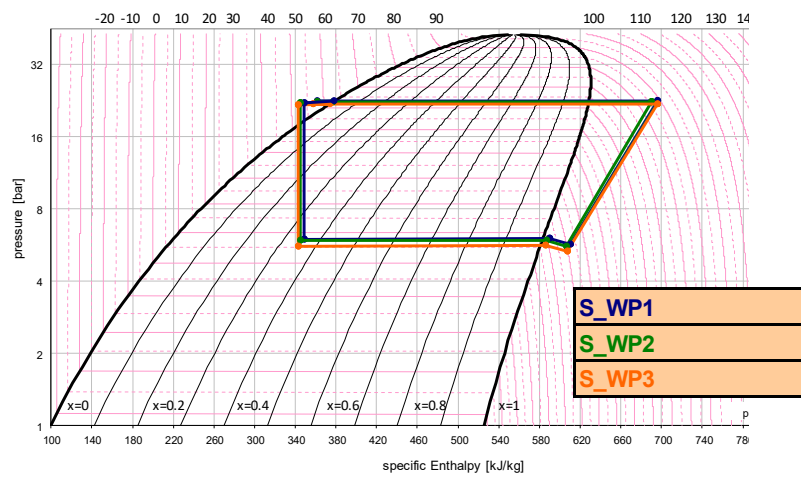
Figure 72: Exemplary results of Step-2 summer case measurements (S_WP1 to S_WP3)

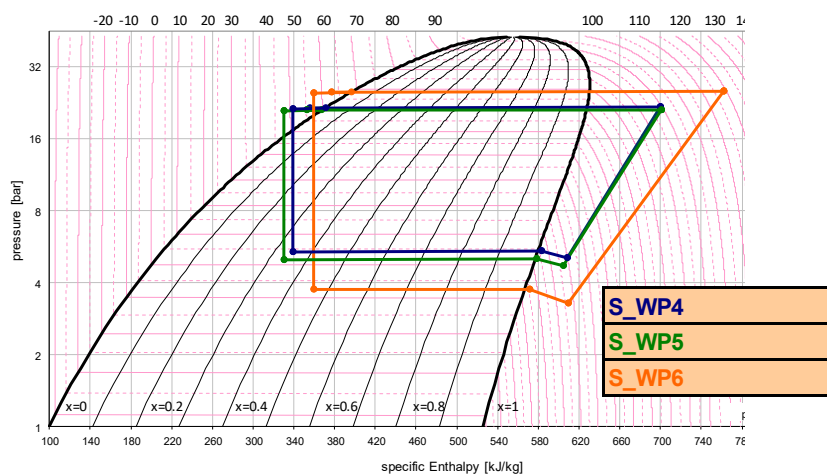
Figure 73: Exemplary results of Step-2 summer case measurements (S_WP4 to S_WP6)

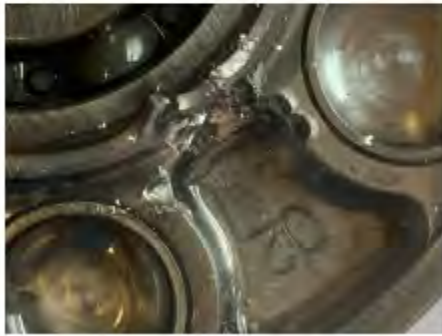
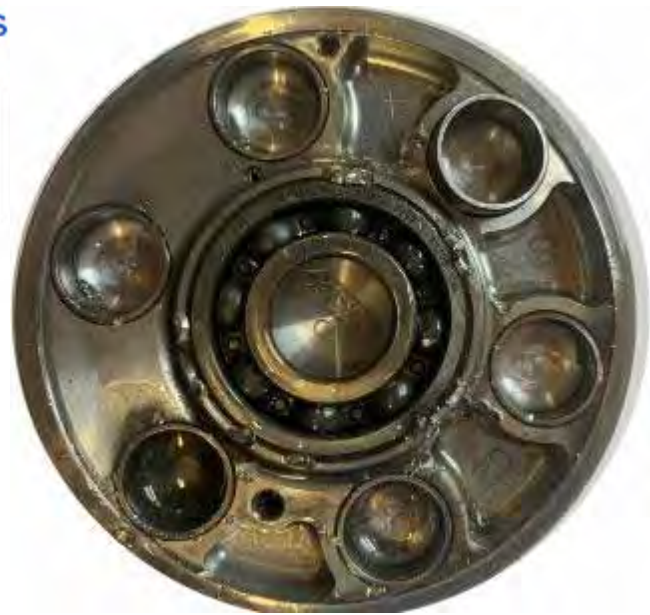
Figure 74: Damage of compressor no. 2 (Source OBR)

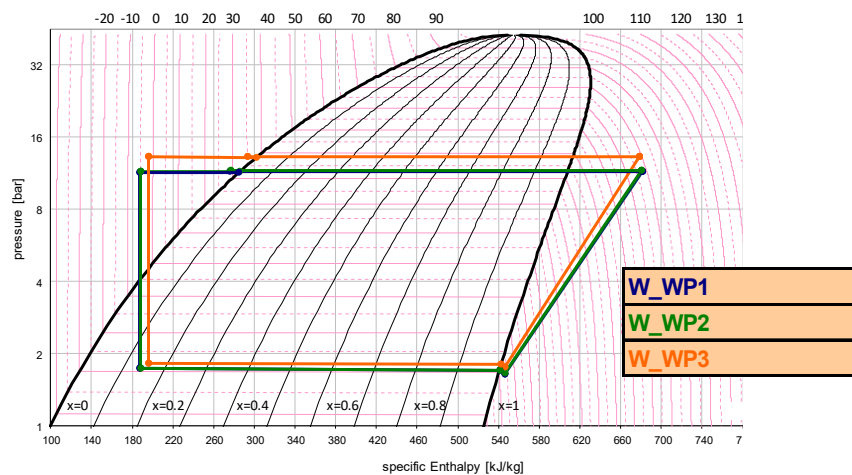
Figure 75: Exemplary results of Step-2 winter case measurements (W_WP1 to W_WP3)
